UPDATED RESOURCE CONSERVATION AND RECOVERY ACT (RCRA) CONTINGENCY PLAN
IMPLEMENTATION REPORT (CPIR) NO. 93-007 - TGH-472-93

RCRA CONTINGENCY PLAN
IMPLEMENTATION REPORT No. 93-007
ROCKY FLATS PLANT
EPA ID NUMBER CO7890010526

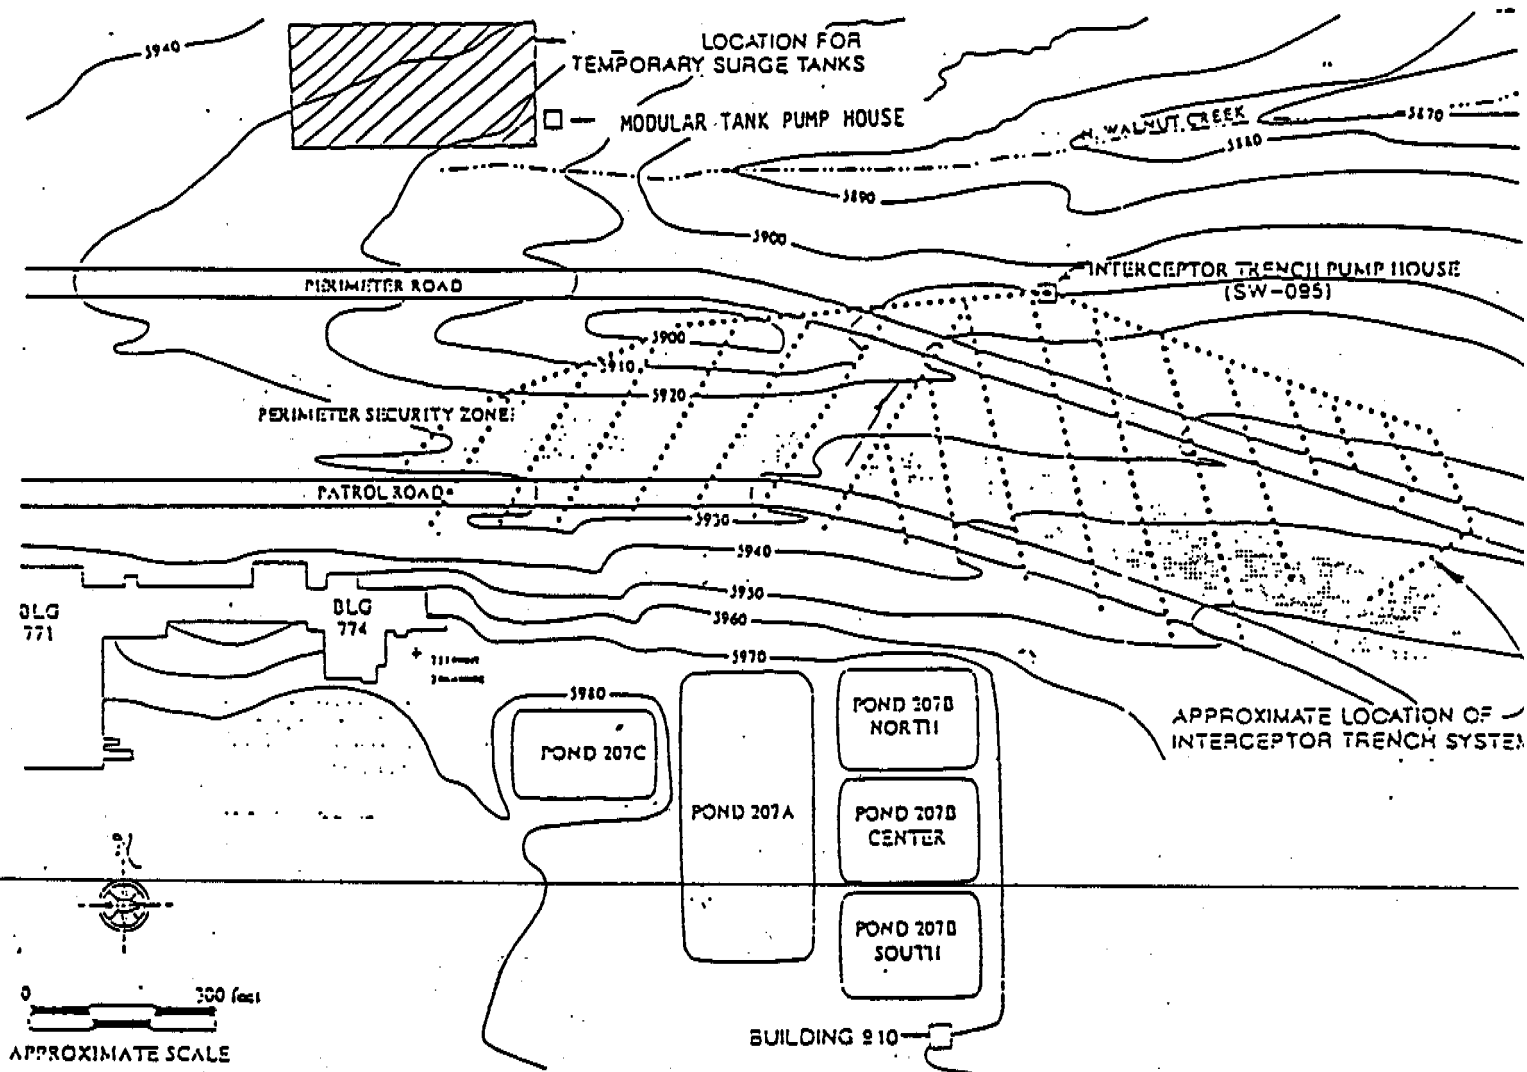
FIGURE 1

The system includes a) Interceptor Trench System (ITS), b) three (3) Modular Storage Tanks, c) Building 910 Treatment System, and all related ancillary equipment. Figure 1 is a system layout and Figure 2 is a schematic of the transfer systems. The following is a description of the system components:

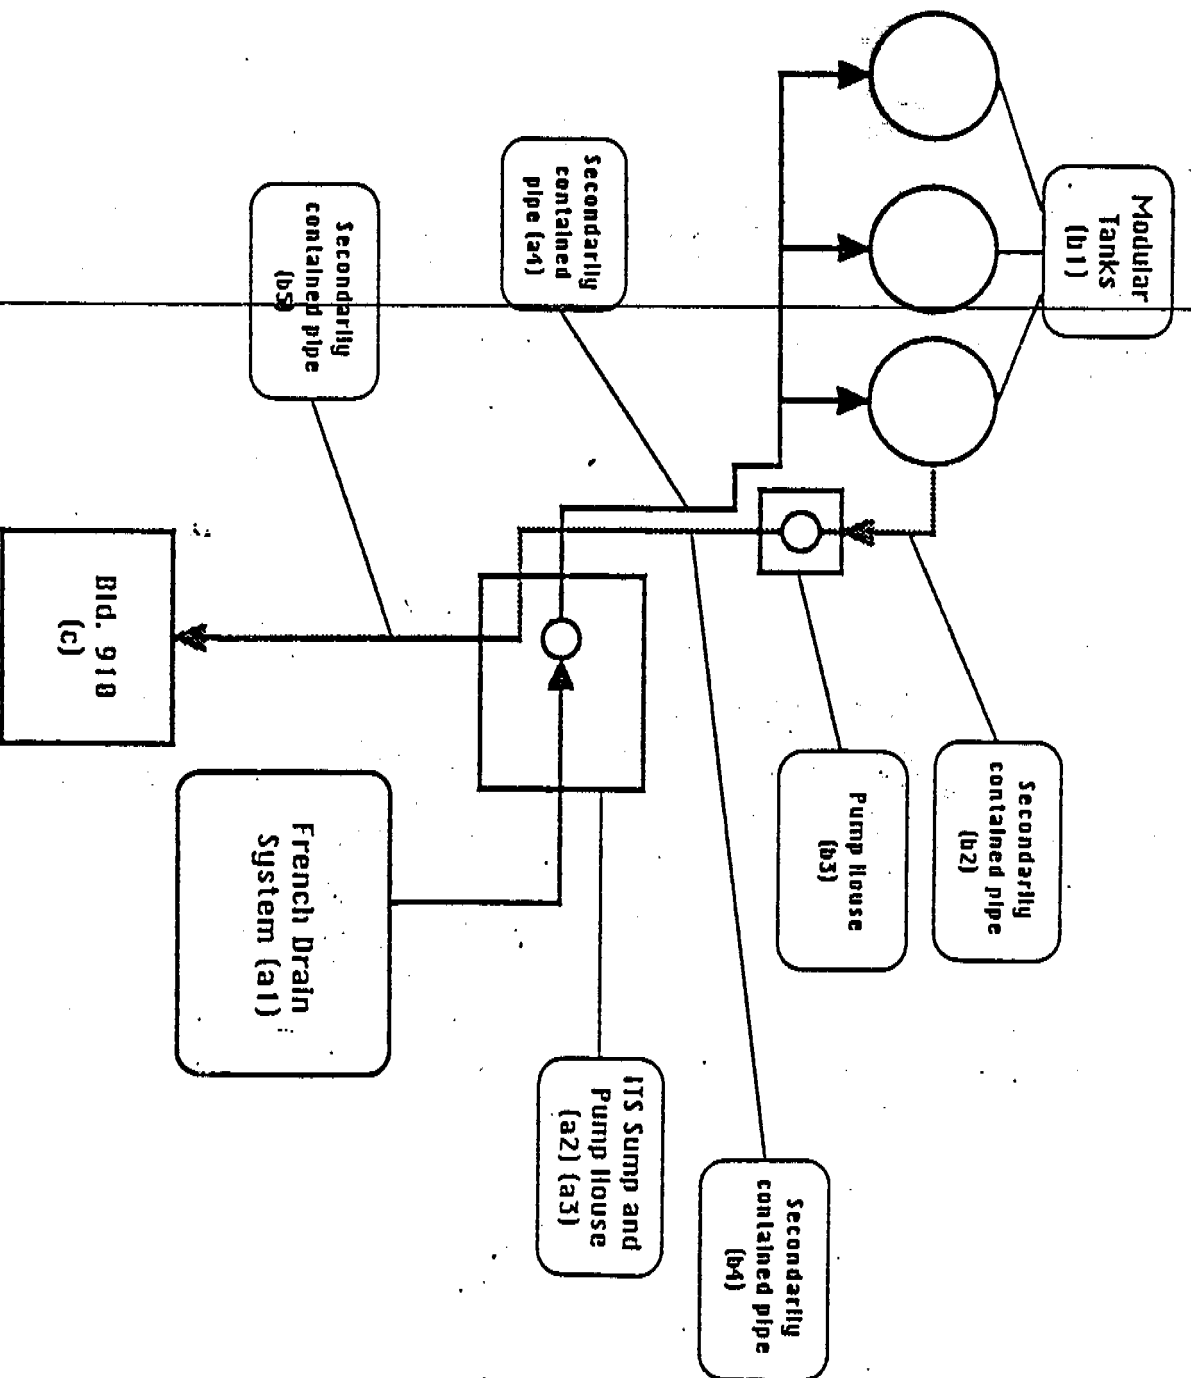
FIGURE 2

Prior to 1:00 p.m. on July 20, 1993, a leak occurred in the primary containment piping (reference Figure 2 - item (b4)) located between the modular tanks and the ITS sump (reference Figure 2 - item a2) which allowed waste to leak into the secondary containment. Due to the location of the leak in the pipeline, the hazardous waste that leaked into the secondary containment overflowed back into the Modular Tank pumphouse (reference Figure 2 - item b3) and also gravity-drained through a failed hose connection on the secondary containment piping (reference Figure 2 - item a2). The failed hose connection is located within the ITS sump. The ITS sump is equipped with an automatic level controls and the material that spilled into the ITS sump was pumped back into the Modular Tanks. The hazardous waste that overflowed into the Modular Tank pumphouse was fully contained in the pumphouse secondary containment. When the liquid level in the pumphouse secondary containment rose, the leak detection system was activated, the local alarm was activated, and the pumps were automatically shut down. The remote alarm via telemetry to Building 374 did not, however, function. Problems had occurred previously and this alarm was not reliable; therefore, it had not been considered operational and compensatory measures were in place to perform daily checks of the local alarm panel. This deficiency had been identified as an open item to be corrected.

- b) Hazardous waste continued to drain from the hose connection on the secondary containment into the ITS sump for several hours: the sump was checked several times after the problem was initially discovered at about 1:30 p.m. on July 20; and drainage from the secondary containment had ceased by 4:30 p.m. on July 20 when the transfer piping secondary containment drained to the low point of the line in the ITS sump. The material that drained into the sump was automatically pumped back into the Modular Tank system, and was removed from the sump by 5:00 p.m. on July 20.

The released material is, however, RCRA F-listed hazardous waste. In accordance with 6 CCR 1007-3, the pumping operation at the ITS sump is considered a waste generation point (reference Figure 2 - item a3). At this

- Repair the primary transfer line,
 - Repair or modify the portion of the secondary containment of the transfer line (the hose connection) within the ITS sump that failed and resulted in the leak of hazardous waste from the secondary containment system, and

- Retest the primary line following the repair.
- 6) In accordance with 6 CCR 1007-3 Part 264.196 (f)- Certification of major repairs: The repair of the system is not expected to be extensive (per §265.196(f), examples of extensive repairs are installation of an internal liner or repair of a ruptured vessel); therefore the certification by an independent, qualified, registered, professional engineer may not be required prior to resuming operations.
